NAME	Dr. Horton Building			REF. NO. 242
ADDRESS	315 West Third Street			
CITY	Santa Ana	ZIP	92701	ORANGE COUNTY
YEAR BUILT	1928	LOCAL REGISTER CATEGORY: Key		
HISTORIC DISTRICT	Downtown Santa Ana	NEIGHBORHOOD		
NATIONAL REGISTER CRITERIA FOR EVALUATION	C	NATIONAL REGISTER STATUS CODE	1D

ARCHITECTURAL STYLE: Mission/Spanish Colonial Revival

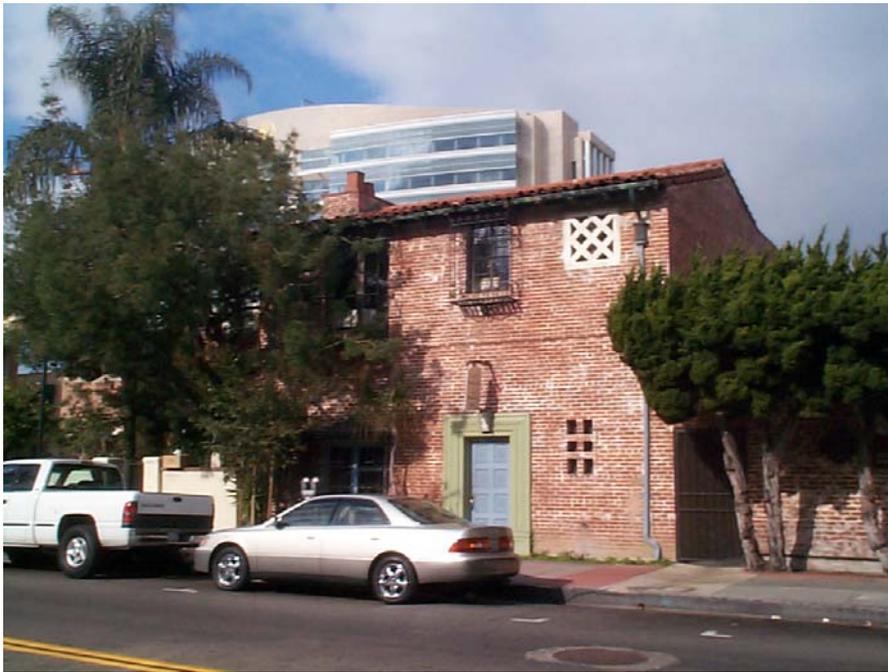
This two-story office building is located on the north side of West Third Street between Broadway and Birch Streets. Of brick construction, the Spanish Colonial Revival style building has a concrete foundation and a side gable roof with exposed wood rafters in the narrow overhanging eaves. The roof is covered in red clay tiles. An ornately paneled wood main entrance door is outlined by a wide molded wood surround. To the west of the entrance door, a pair of wood French doors are screened from the street by a wrought iron grille. Windows include metal casements with wrought iron balconies, and brick and concrete latticework openings in the masonry walls. Decorative tile embellishes the attached chimney on the west elevation. Notable features include a courtyard embellished with a fishpond. A large poured concrete addition has been added to the west end of the building; otherwise, the design appears to be largely intact.

Character-defining exterior features of the Dr. Horton Building which should be preserved include, but are not limited to: brick walls banded by raised brick stringcourse; side-gable roof; red clay tile roof cladding; bracketed roof overhang; brick chimney embellished with decorative tile; wrought iron detailing including window grilles and balconies; cast stone window grille; brick latticework window grille; entry door surround; paneled wood entry door; original fenestration including French doors and metal casement windows; and the courtyard.
